Thurston Pond

Stormwater Repairs Update

July 27, 2021

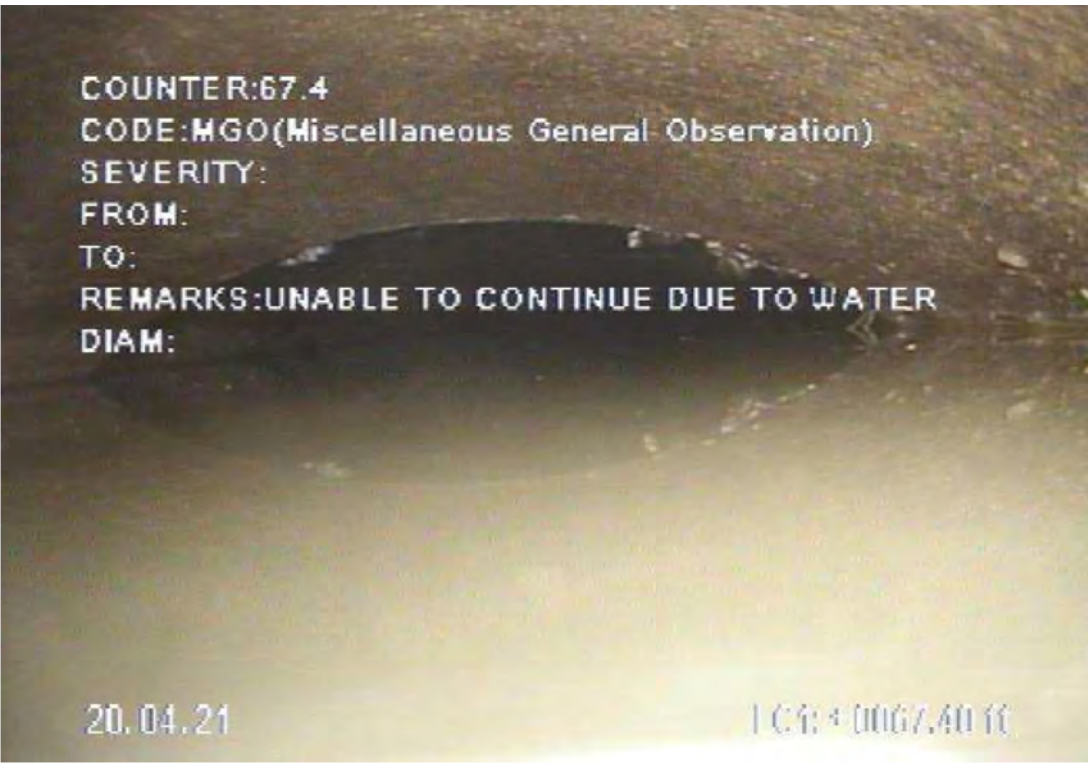
Water Level at 100% at 67'

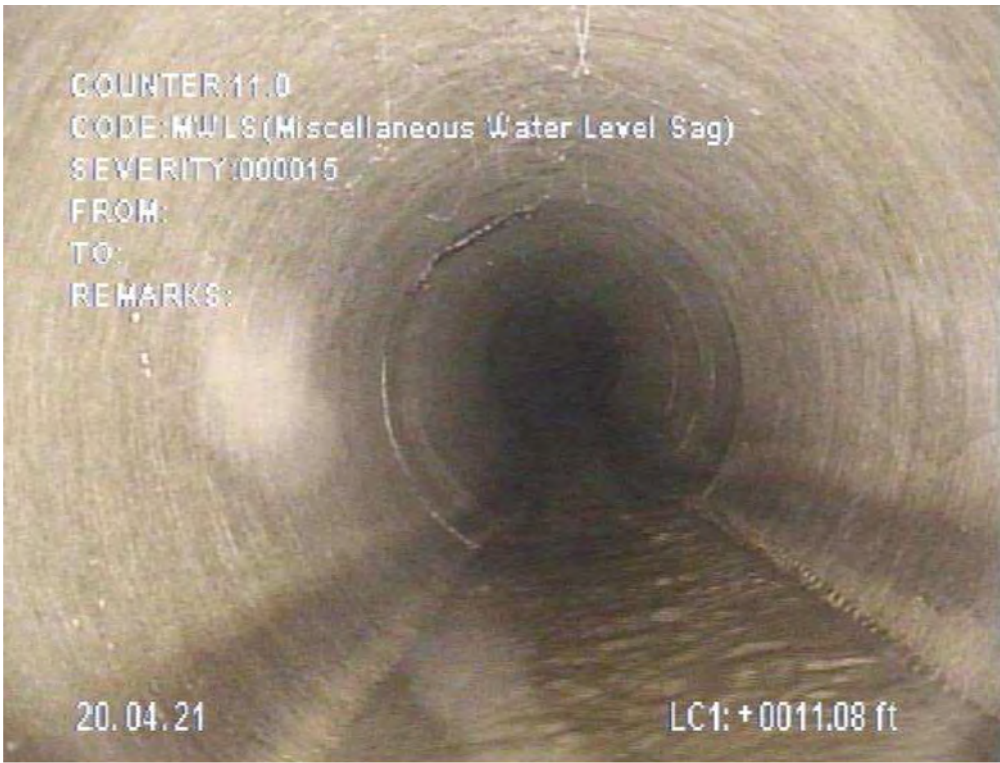
Flow Levels at Downstream End

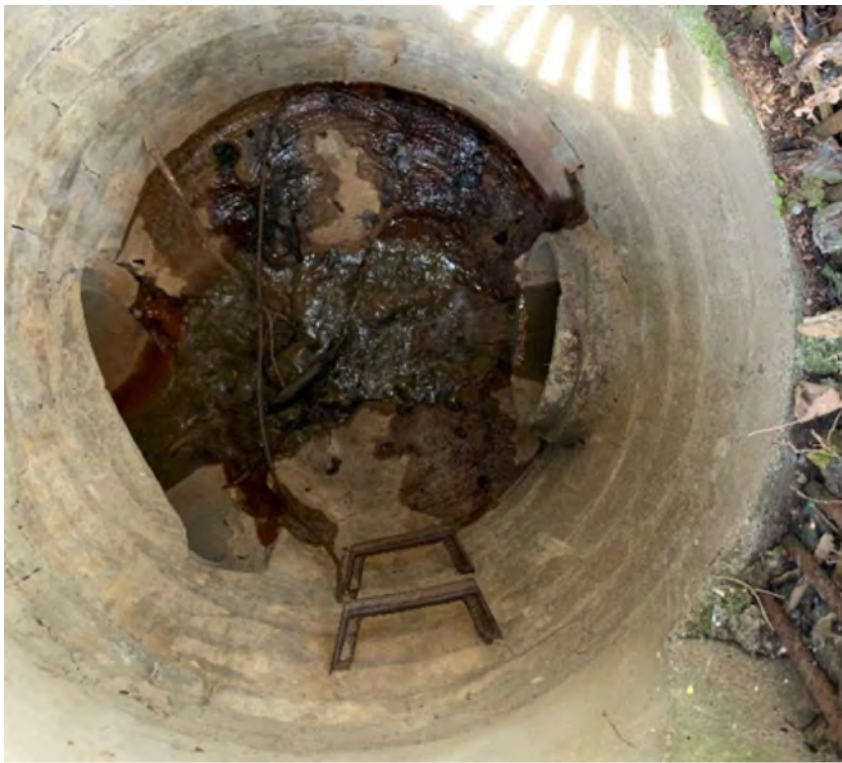
Downstream End of Pipe

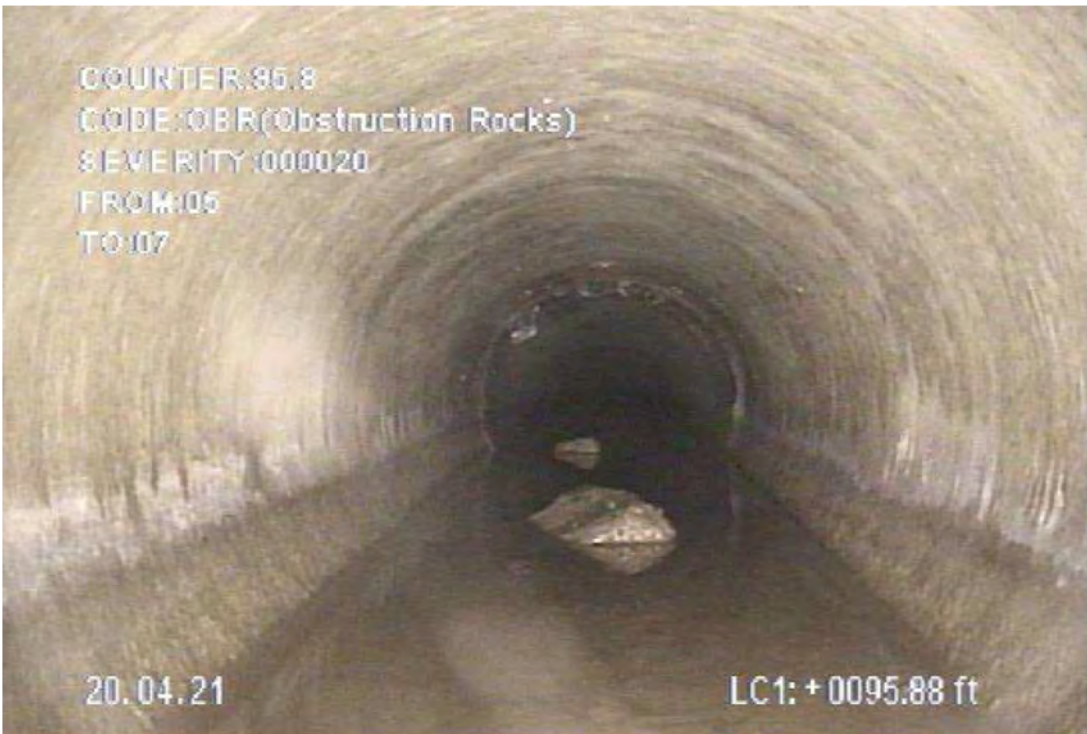
Sand and Gravel Debris in Pipe
on Downstream Side

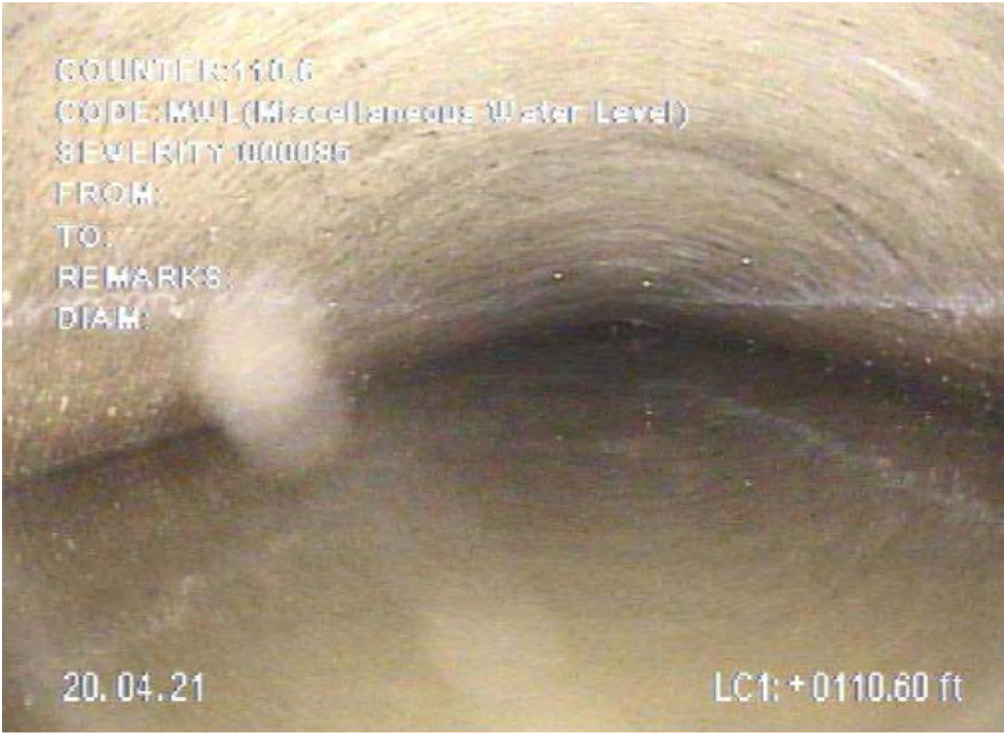
Water Level at 100% at 114'
