Thurston Pond

Stormwater Repairs Update

July 27, 2021

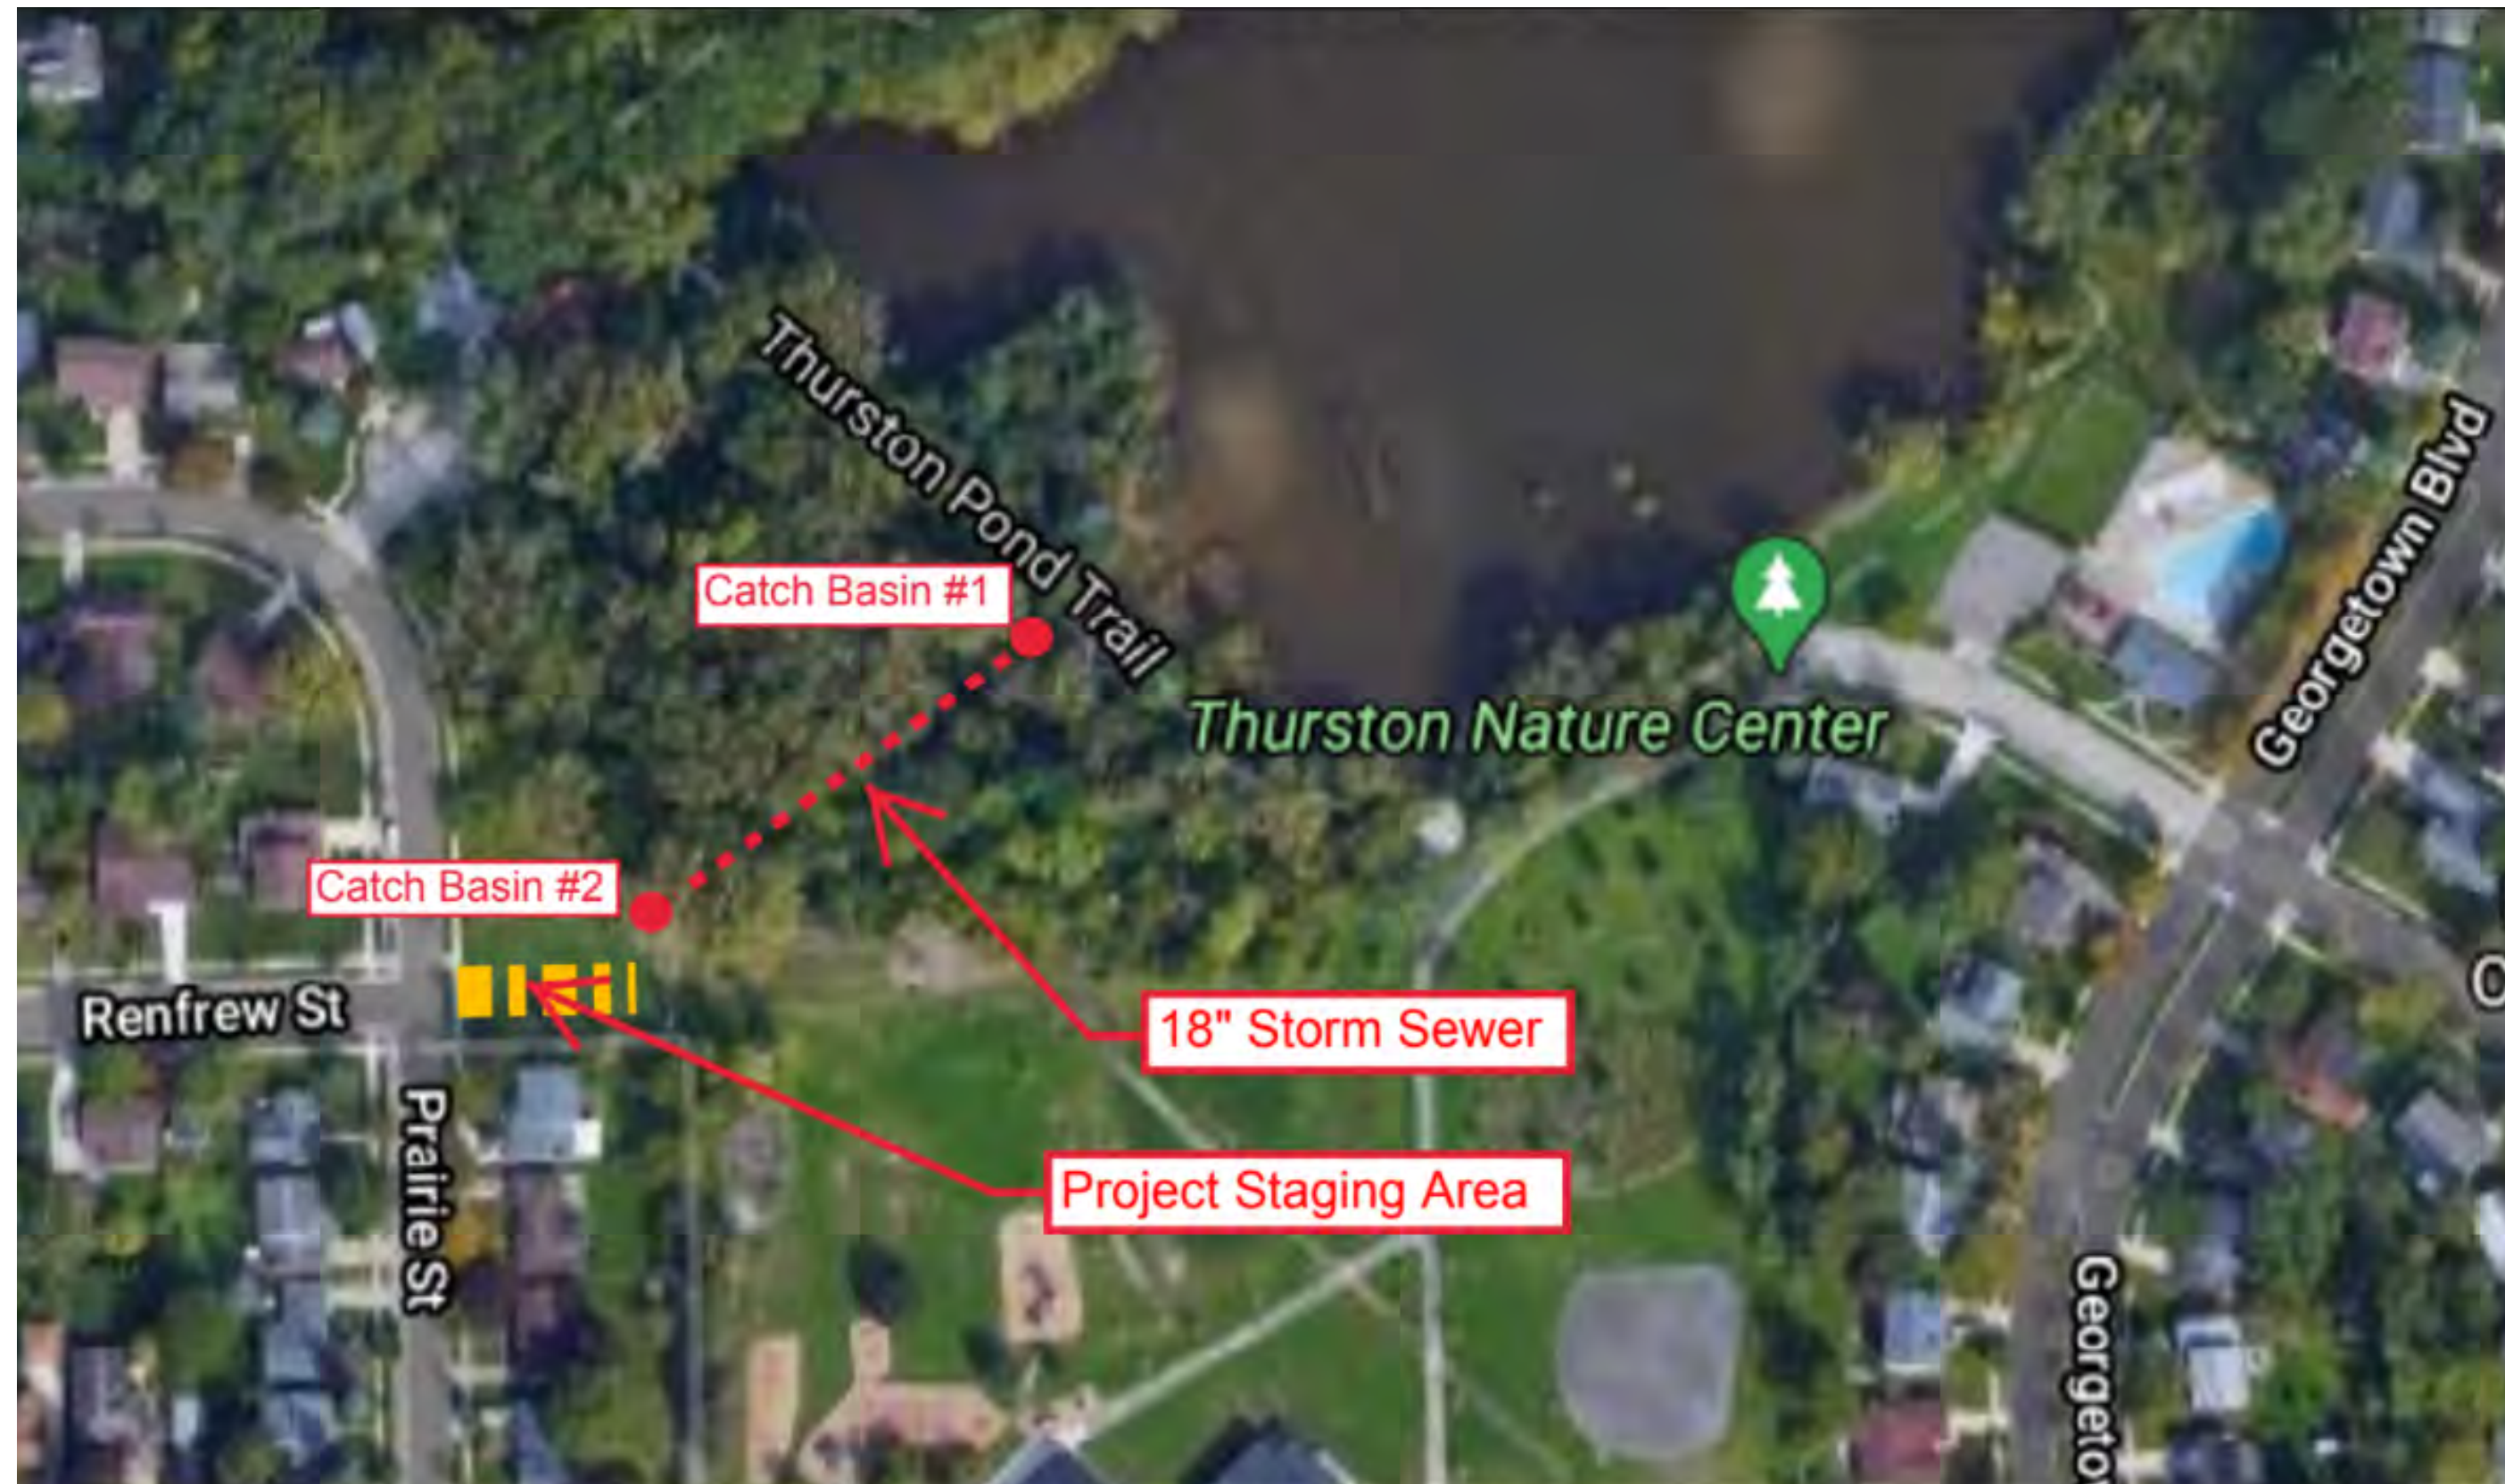
AAPS has recently observed two structural defects in the Thurston Pond storm outlet system:

- An 18" storm pipe has a structural failure and collapse, starting approx. 60 ft from the pond. The pipe connects the Thurston pond to the City of Ann Arbor storm water system and serves to manage pond water levels
- The embankment at the outlet control structure has been undermined and detained storm water is free flowing under the embankment.

These defects need to be repaired before school goes back into session on August 30, 2021.

The storm sewer repair will require the pipe to be exposed with an excavation approximately 10' deep and 40' long.

In order to effectively and safely make the repair, the pond level will need to be lowered to minimize the presence of water during the repair.
